FAYETTE NEW CITY LAKE DAM

HOWARD COUNTY, MISSOURI

MO 10130

**PHASE 1 INSPECTION REPORT
NATIONAL DAM SAFETY PROGRAM**

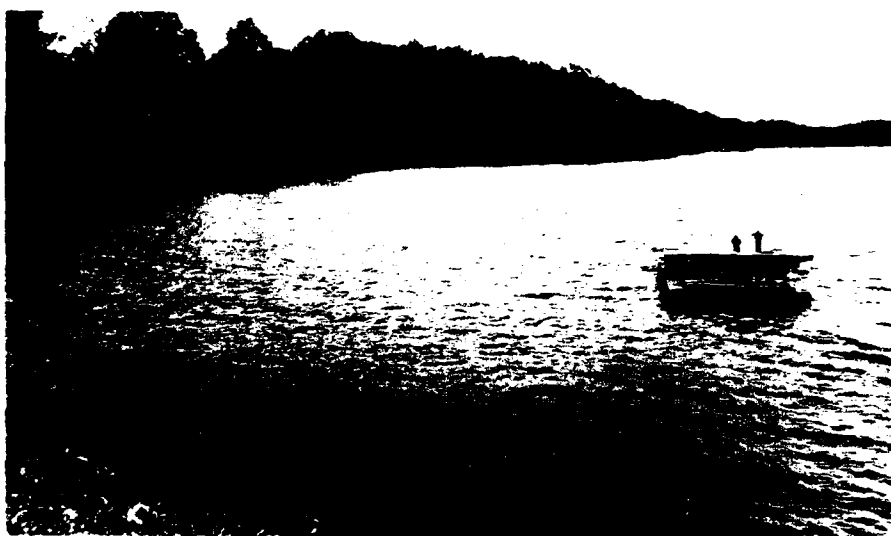
- (2) Water supply inlet. The water supply inlet riser stands in the reservoir near the right abutment. A 10-inch water supply line is said to lead away from the riser. It is not known whether this water line can be used as an emergency drawdown works. No details of the water supply inlet are known. It is not known whether any valves exist on the 10-inch water supply line. No information is available concerning the water supply outlet works. No other outlet works were found.

PHOTO NO. 3
INLET STRUCTURE
TAKEN FROM STA. 5+00

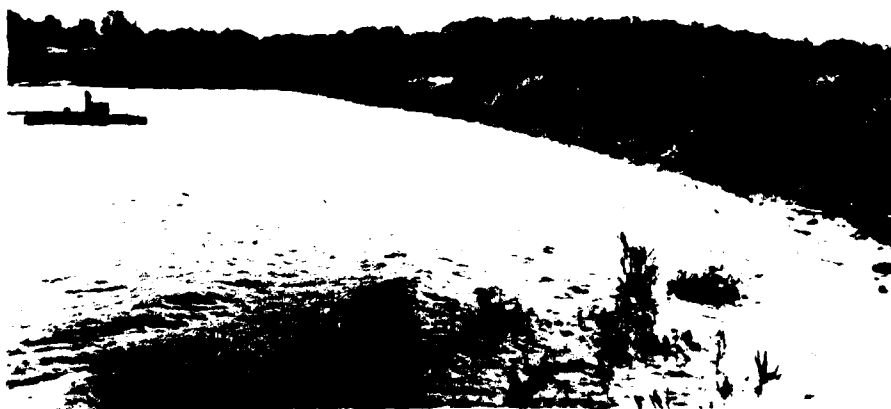
PHOTO NO. 4
INLET STRUCTURE AND
UPSTREAM SLOPE TAKEN
FROM RIGHT ABUTMENT

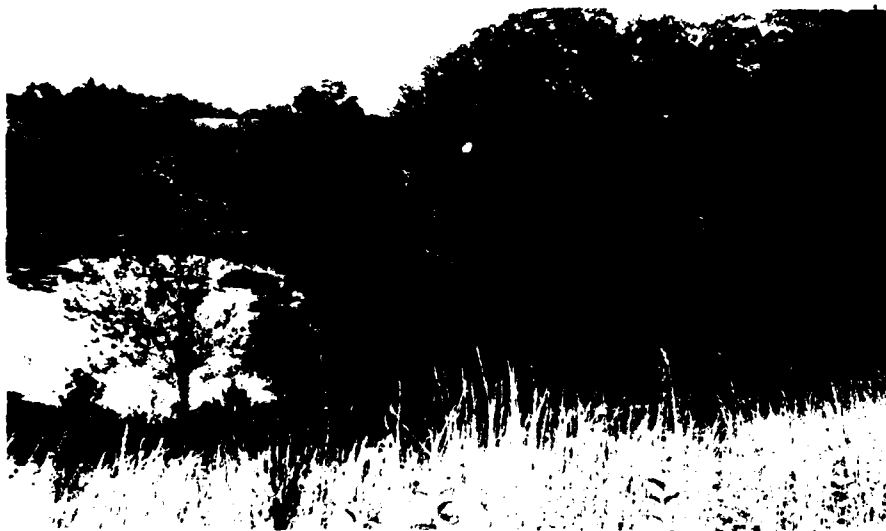
PHOTO NO. 6
RIGHT ABUTMENT
TAKEN FROM STA. 4+70

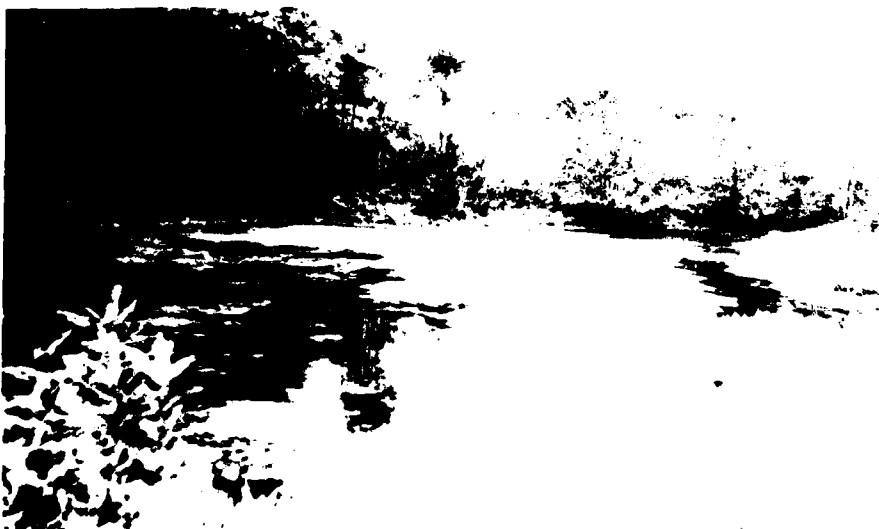
Near the right abutment there is a diked pond approximately 50 feet downstream from the toe of the embankment. The pond is retained by a road embankment and has a 6-inch pipe riser to maintain a pool level. At the time of the inspection the water level was below the top of the riser, consequently no flow could be measured. This water may be from seepage in the old stream channel. Between this pond and the toe of the embankment was an unexplained hole, approximately 8 feet by 5 feet and up to 2 feet deep. The bottom of the hole was above the level of the pond, and there was no water in the hole.

The source of water in the pond downstream from the toe of the dam and the affects of this impoundment on structural stability of the dam should be investigated. The cause and repair of the hole between the pond and the downstream toe of the dam should be investigated.

PHOTO NO. 7
DIKED POOL BELOW
RIGHT ABUTMENT

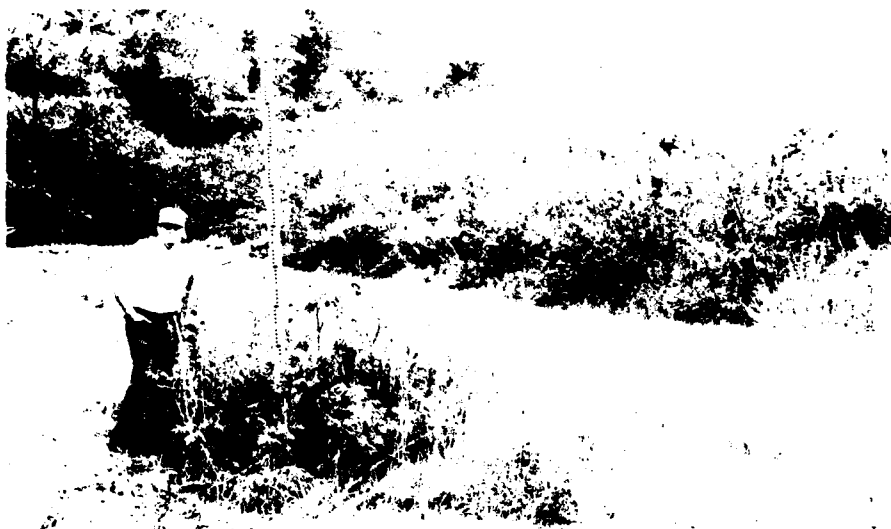
PHOTO NO. 9
DEPRESSION NEAR
TOE. STA. 4+50

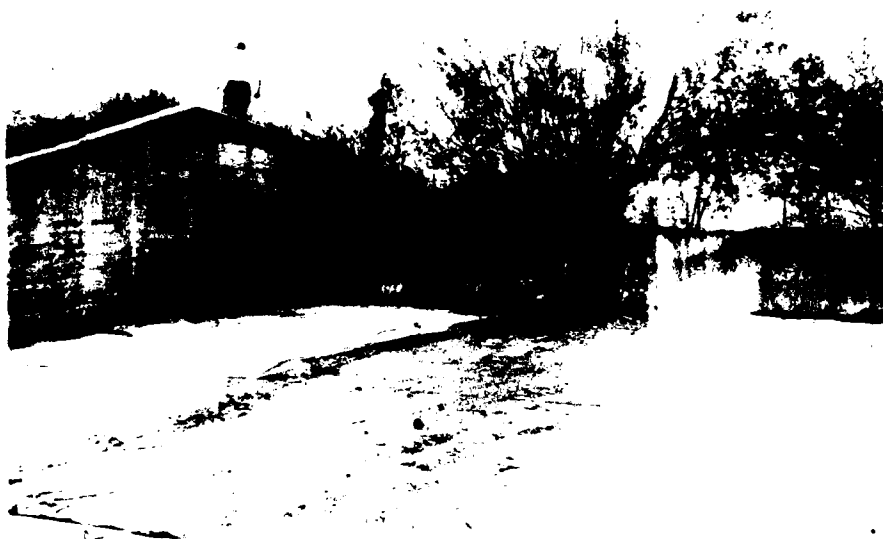
- (1) Spillway. The spillway consists of an ogee weir with a concrete outfall or exit channel, built at the left abutment. Spillway details are shown in Appendix C. The inlet to the spillway is riprapped and was found to be nearly blocked with trees and bushes. No erosion of the inlet was observed. The concrete in the ogee section is deteriorating, and the weir had several horizontal cracks from which water was seeping. A wire fence along the top of the weir could affect the operation of the spillway. The seepage water coming out of the ogee weir flowed along the concrete floor of the channel and disappeared into a joint about 25 feet downstream from the weir (see Photo No. 12).

PHOTO NO. 12
WATER LEAKING FROM
CRACK IN WEIR

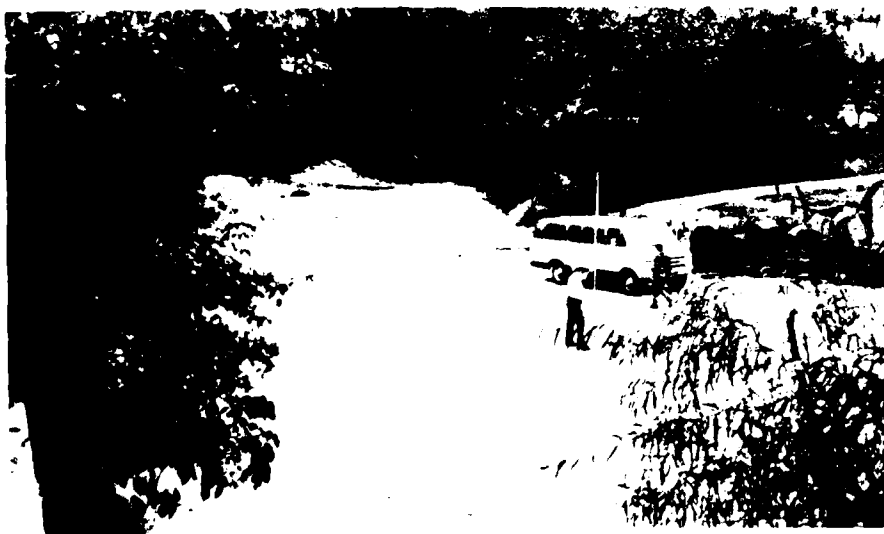
e. Downstream Channel. The bottom of the outfall or exit channel below the ogee weir is paved with concrete. Vertical concrete walls and limestone masonry walls form the sides of the channel where it descends through the embankment. Beyond approximately the toe of the embankment, the sides of the channel are formed of broomed concrete. This appears to be a repair of erosion damage. At the end of the concrete channel bottom, the channel narrows considerably and is pretty well overgrown with weeds, bushes, and trees. Channel erosion is not significant. Approximately 1000 feet downstream the channel flows into Rogers Lake.

PHOTO NO. 13
DOWNSTREAM FROM
OGEE SPILLWAY
